TECHNICAL BULLETIN

Bulletin #: MY21-001
Date: November 15th, 2021

Subject: Alpine Trail Rocker Link & Upper Shock Mount Assembly
Models Affected: 2020-2021 Alpine Trail 7 and 8, Alpine Trail XR, Alpine Trail Carbon 1, Alpine Trail Carbon 2, Alpine Trail E1, Alpine Trail E2

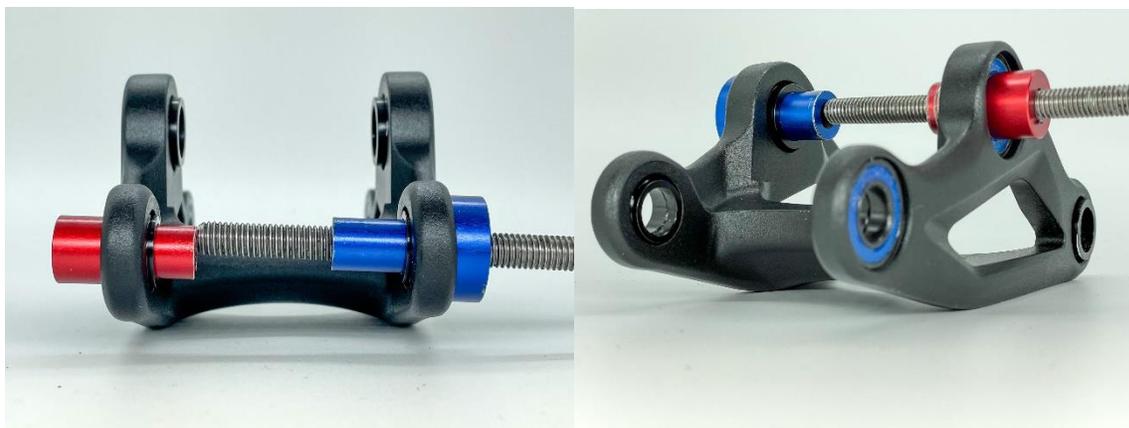
- 1) Put the bike in a repair stand, remove the rear wheel from the frame, the upper shock bolts, and then the rocker link.
- 2) Using a bearing press; check the alignment of shock mount bearings and main pivot bearings.

- 3) If there is evidence of poor alignment, remove each bearing **ONE AT A TIME** with a bearing press. Apply green Loctite to the outside of each bearing and then re-install into the link.

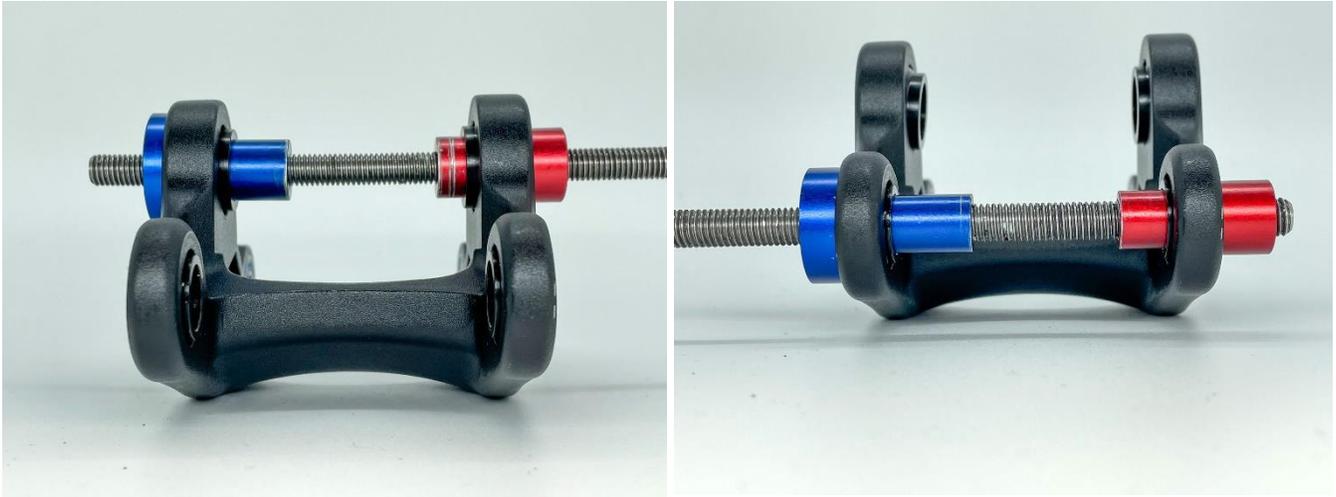
- 4) Once the bearings are re-pressed, confirm that the bearings are properly aligned.

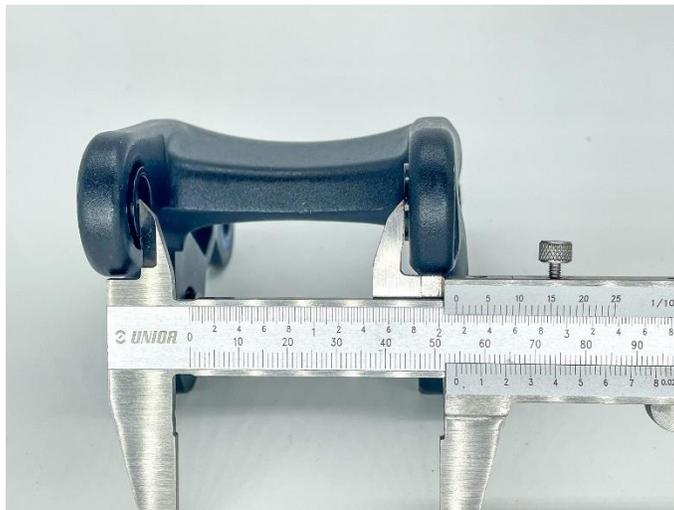
- 5) Measure the upper shock linkage width, with spacers installed, with a caliper (**DO NOT USE A RULER OR MEASURING TAPE** – it is not precise enough to measure this distance accurately).
- Make sure to measure in multiple locations to get the most accurate measurement; be sure to measure the width at a 12, 3, 6 and 9 o'clock position.
 - If the gap measures between 54-54.2mm, it's within spec and good to be used.
 - If the gap measures at 54.21mm or larger, it is out of spec.

- 6) If the linkage is good, re-install the shock back onto the bike. Apply grease and blue Loctite; torque to 12 Nm. Reinstall the rear wheel.
- 7) **If the linkage is out of specification, please follow these steps:**
- Using a bearing press to check that both the left and right side bearing on the rocker link are fully seated, then re-measure the gap with spacers installed.
 - If the gap now measures to the correct 54-54.2mm tolerance it is ok to re-install the shock. Again, use the correct grease, Loctite, and torque (12 Nm) values
 - If the gap still measures 54.21mm or more, the link is out of specification and needs to be replaced. If this is the case contact your local Marin warranty manager for support
