# Information on the change of torque for screws of the ONE-SIXTY and ONE-FORTY

12.06.2023

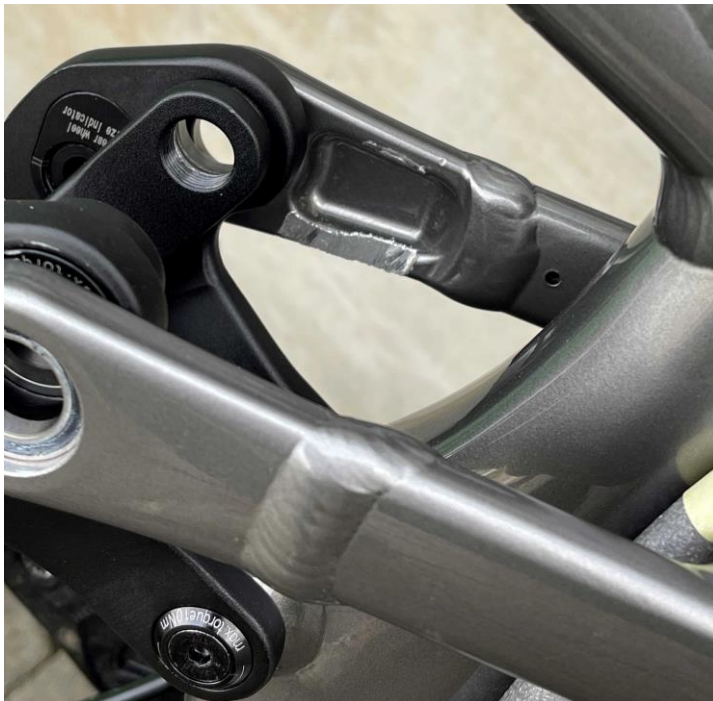
Due to insufficient torque in mass production, the screw that connects the rocker to the shock extension can come loose. Loosening this screw can damage the paint on the inside of the seat stays (see pictures below).

**Please inform your dealers via E-Mail or your B2B portal that they have to increase the torque of the rocker on the delivered bikes to 23-25 Nm.** Please create an awareness that the dealers and final customers check these screws and the brake mount screws from time to time.

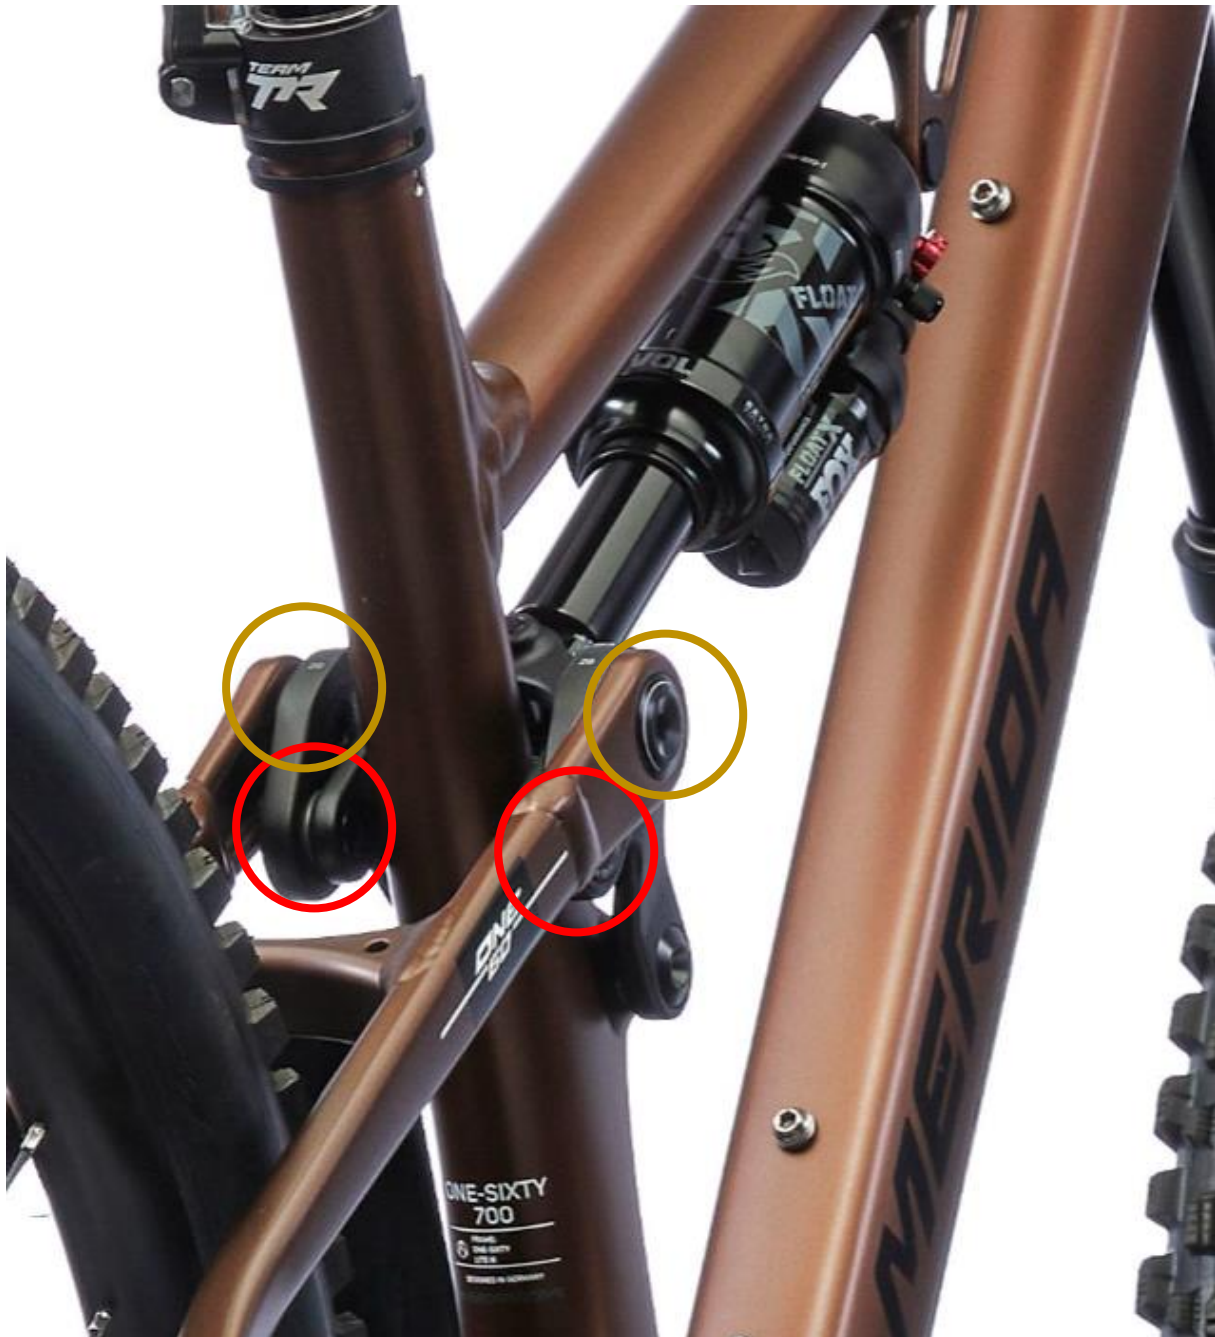
The torque of the screws which connect the rocker with the shock extension (highlighted red below, Nr. 10 [explosion drawing](#)) will be changed from 13-15 Nm to **23-25 Nm**.

Also, the torque of the screws, which connect the seat stay with the rocker (highlighted yellow below, Nr. 17 in the [explosion drawing](#)) will be changed from 13-15 Nm to **23-25 Nm**.

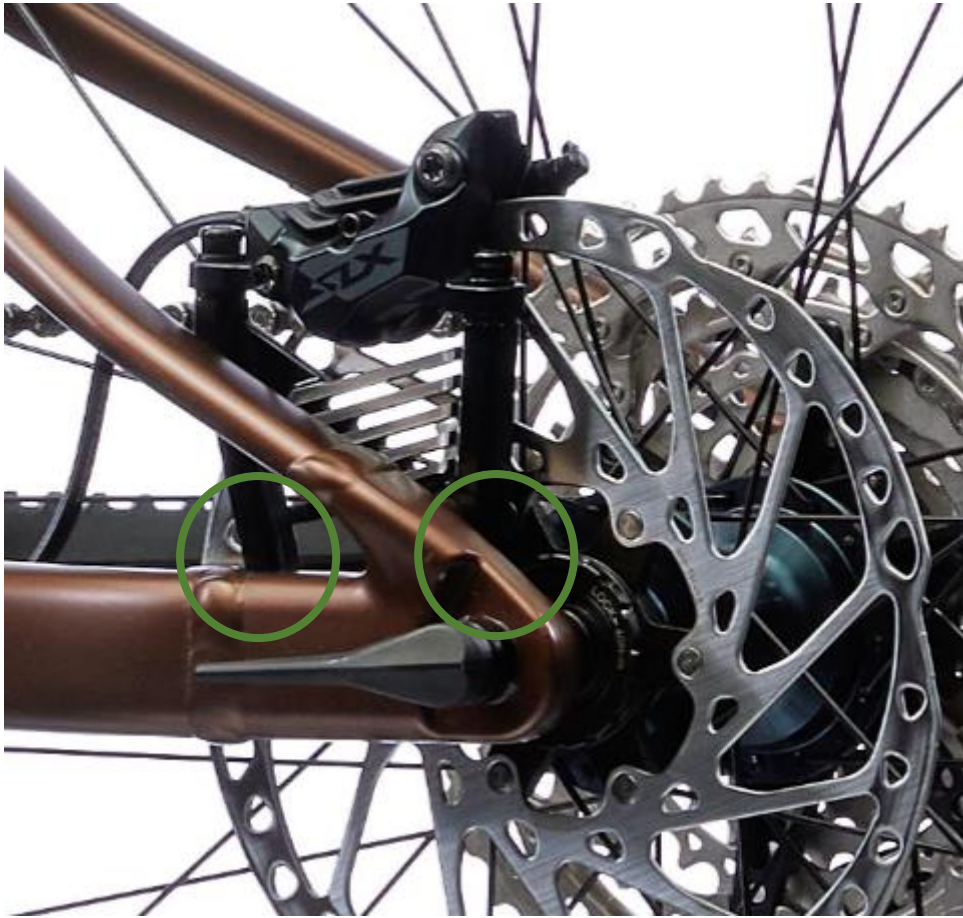
Please also note, that we have increased the torque recommendation of the three brake adapter screws (marked green below, Nr. 17 in the [explosion drawing on the right side](#)) from 6-8 Nm to 11-12 Nm.
